THE SCOPE OF THIS PROJECT IS TO REPLACE THE CORRODED SPRINKLER PIPING IN THE HEALTH SCIENCE BUILDING. THE PIPING WAS SCANNED UTILIZING ULTRASONIC TESTING DEVICES TO DETERMINE THE AMOUNT OF CORROSION IN VARIOUS SEGMENTS OF THE PIPING SYSTEM. THE SCAN RESULTS ARE INCLUDED ON THESE DRAWINGS FOR THE SECTIONS OF PIPING THAT WAS IDENTIFIED AS NEEDING TO BE REPLACED. SOME OF THE SCANS ARE OF THE SMALL DIAMETER PIPING AT THE ARM-OVERS TO THE SPRINKLER HEADS. THE SCOPE SHALL INCLUDE REPLACING ALL THE ARM-OVERS AND EXISTING SPRINKLER HEADS WITH NEW FLEXIBLE SPRINKLER HEADS.

**1 FIRE PROTECTION PIPE REPLACEMENT INFORMATION**

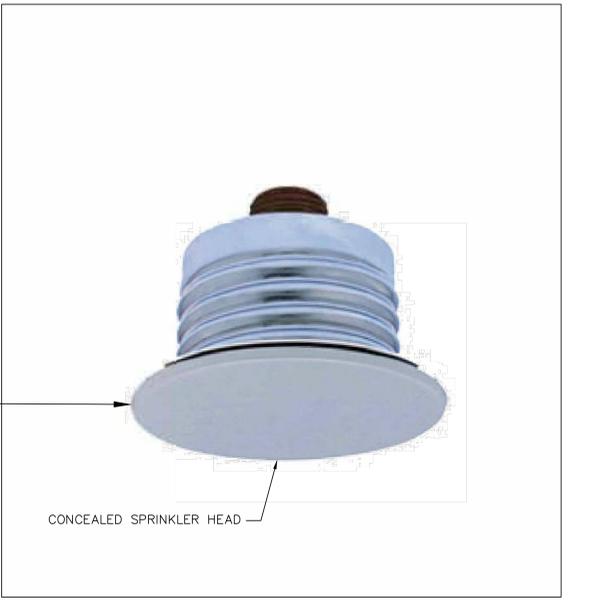
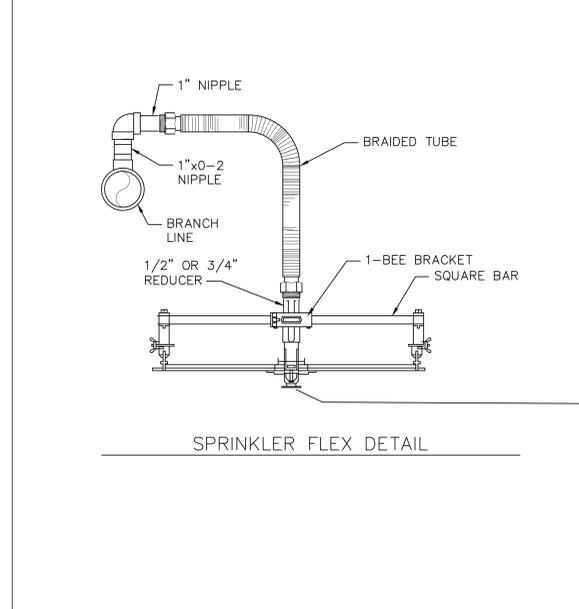
**Test Location No: 51** Photo No: SCC-1-61.jpg Orientation: Side View Detail: Pipe Location / Condition

**Piping Technicalities**  
Location - Health Science Building 3rd Floor Classroom 314. Fire sprinkler branch line to sprinkler head. Test points located between elbow and sprinkler head.

**Testing Indicators: Pipe Replacement is Mandatory** █ A Leak Currently Exists

**Overall Assessment:** Here we show another pipe section where wall thickness readings are high, but a thread leak also exists. Some deficiency with threading, pipe sealant, or fitting-up is suspected. A thread leak at this pipe section defines its replacement as mandatory.
