THE SCOPE OF THIS PROJECT IS TO REPLACE THE CORRODED SPRINKLER PIPING IN THE HEALTH SCIENCE BUILDING. THE PIPING WAS SCANNED UTILIZING ULTRASONIC TESTING DEVICES TO DETERMINE THE AMOUNT OF CORROSION IN VARIOUS SEGMENTS OF THE PIPING SYSTEM. THE SCAN RESULTS ARE INCLUDED ON THESE DRAWINGS FOR THE SECTIONS OF PIPING THAT WAS IDENTIFIED AS NEEDING TO BE REPLACED. SOME OF THE SCANS ARE OF THE SMALL DIAMETER PIPING AT THE ARM-OVERS TO THE SPRINKLER HEADS. THE SCOPE SHALL INCLUDE REPLACING ALL THE ARM-OVERS AND EXISTING SPRINKLER HEADS WITH NEW FLEXIBLE SPRINKLER HEADS.

SPARTANBURG COMMUNITY COLLEGE  
HEALTH SCIENCE BUILDING

SHEET TITLE:  
**FIRE PROTECTION PIPE REPLACEMENT INFORMATION**

SCC-RE-BID HSB Fire Sprinkler Modifications

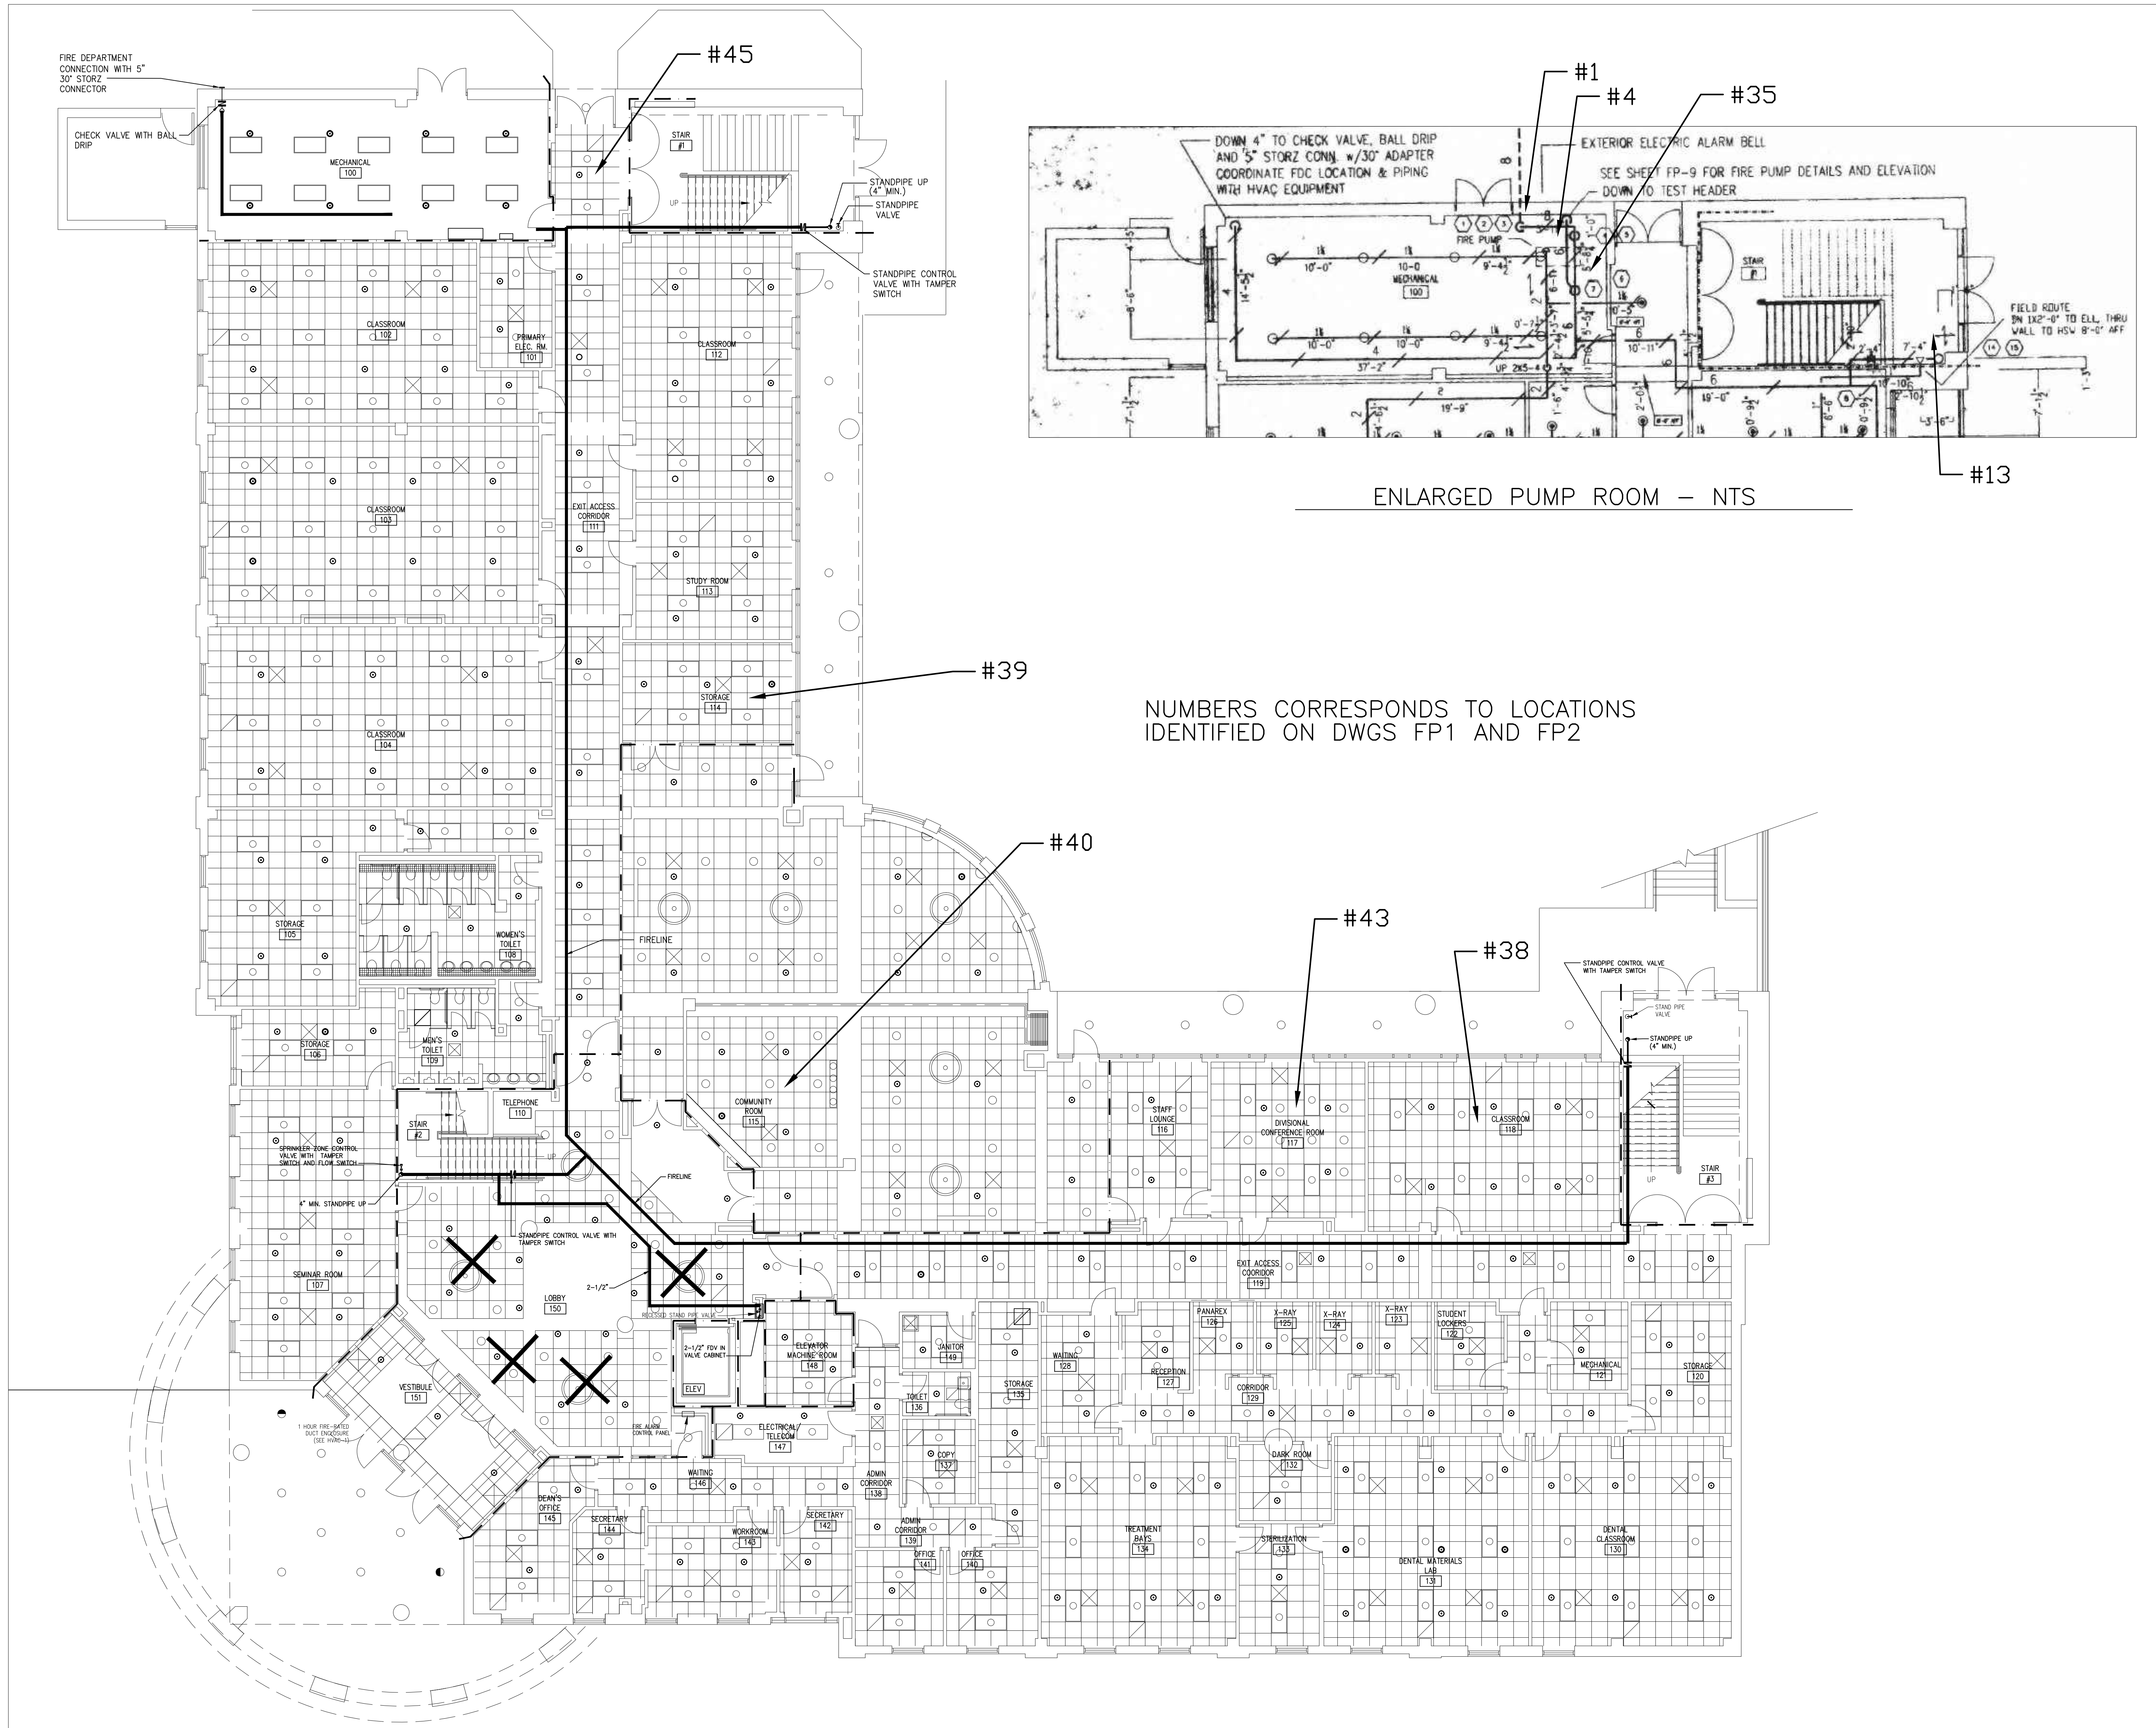
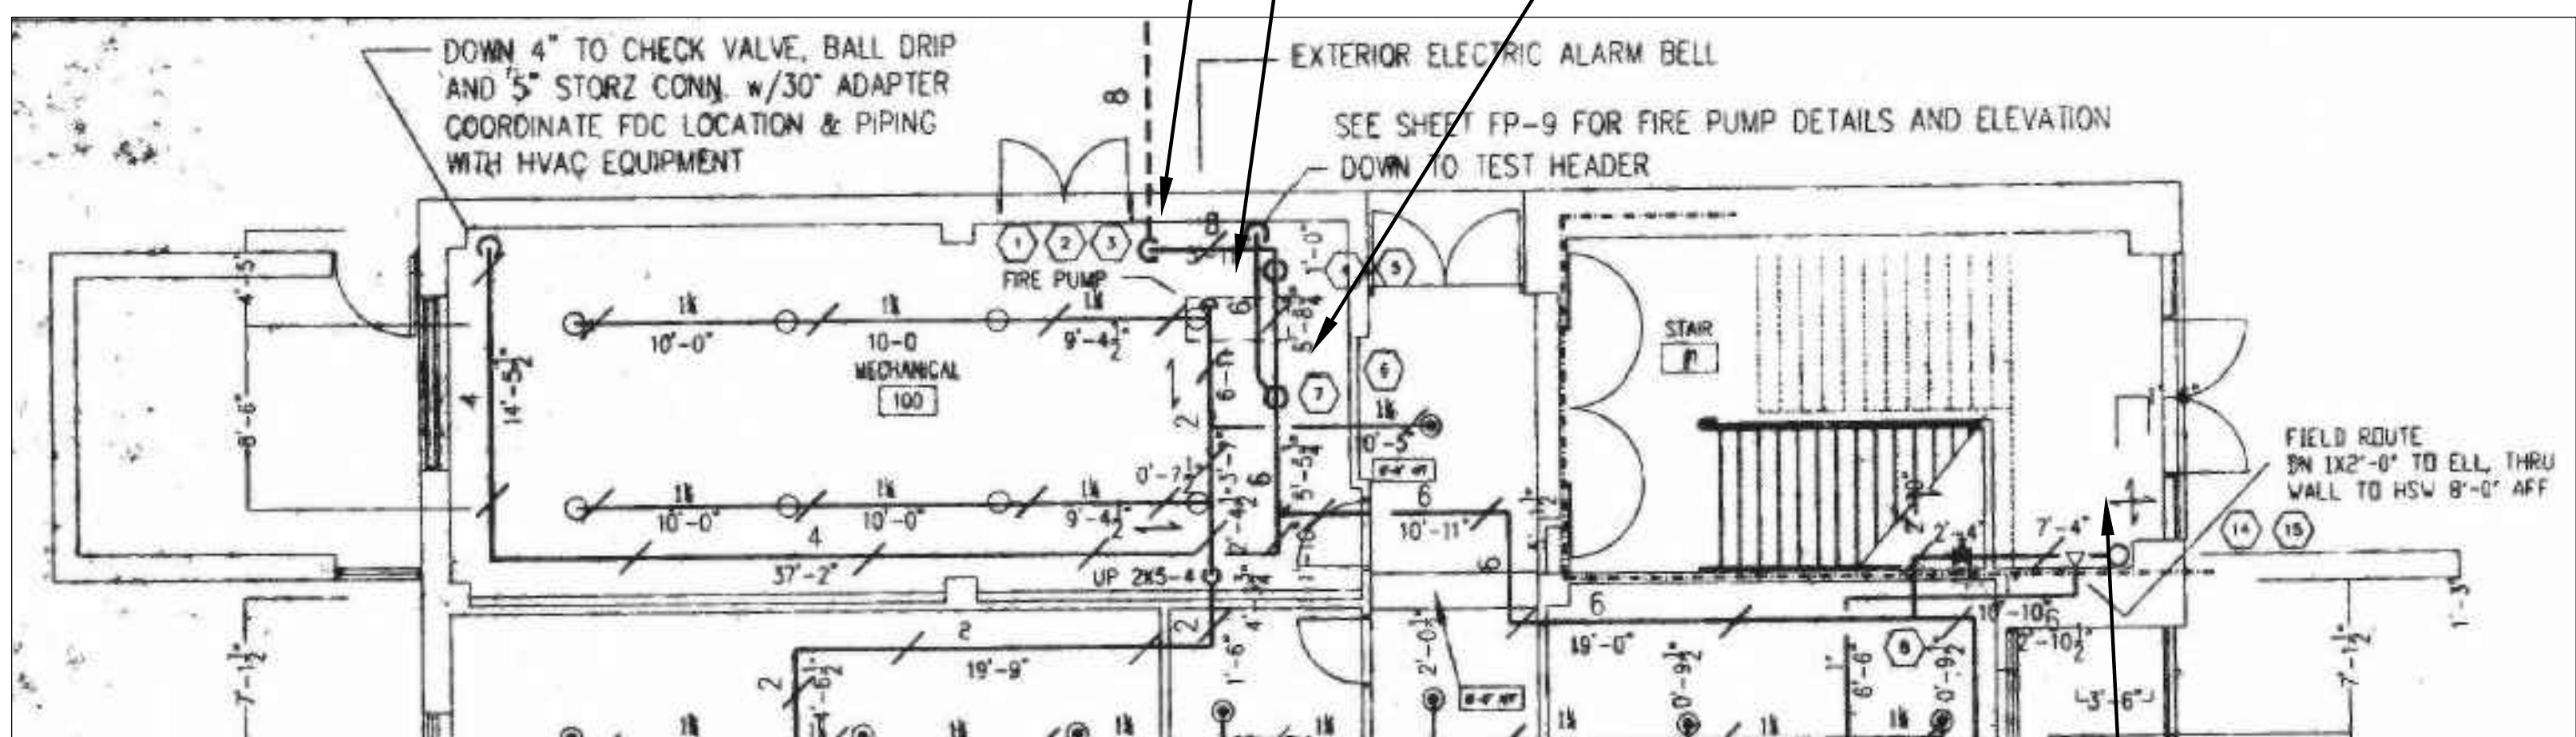
ENLARGED PUMP ROOM - NTS

NUMBERS CORRESPONDS TO LOCATIONS IDENTIFIED ON DWGS FP1 AND FP2

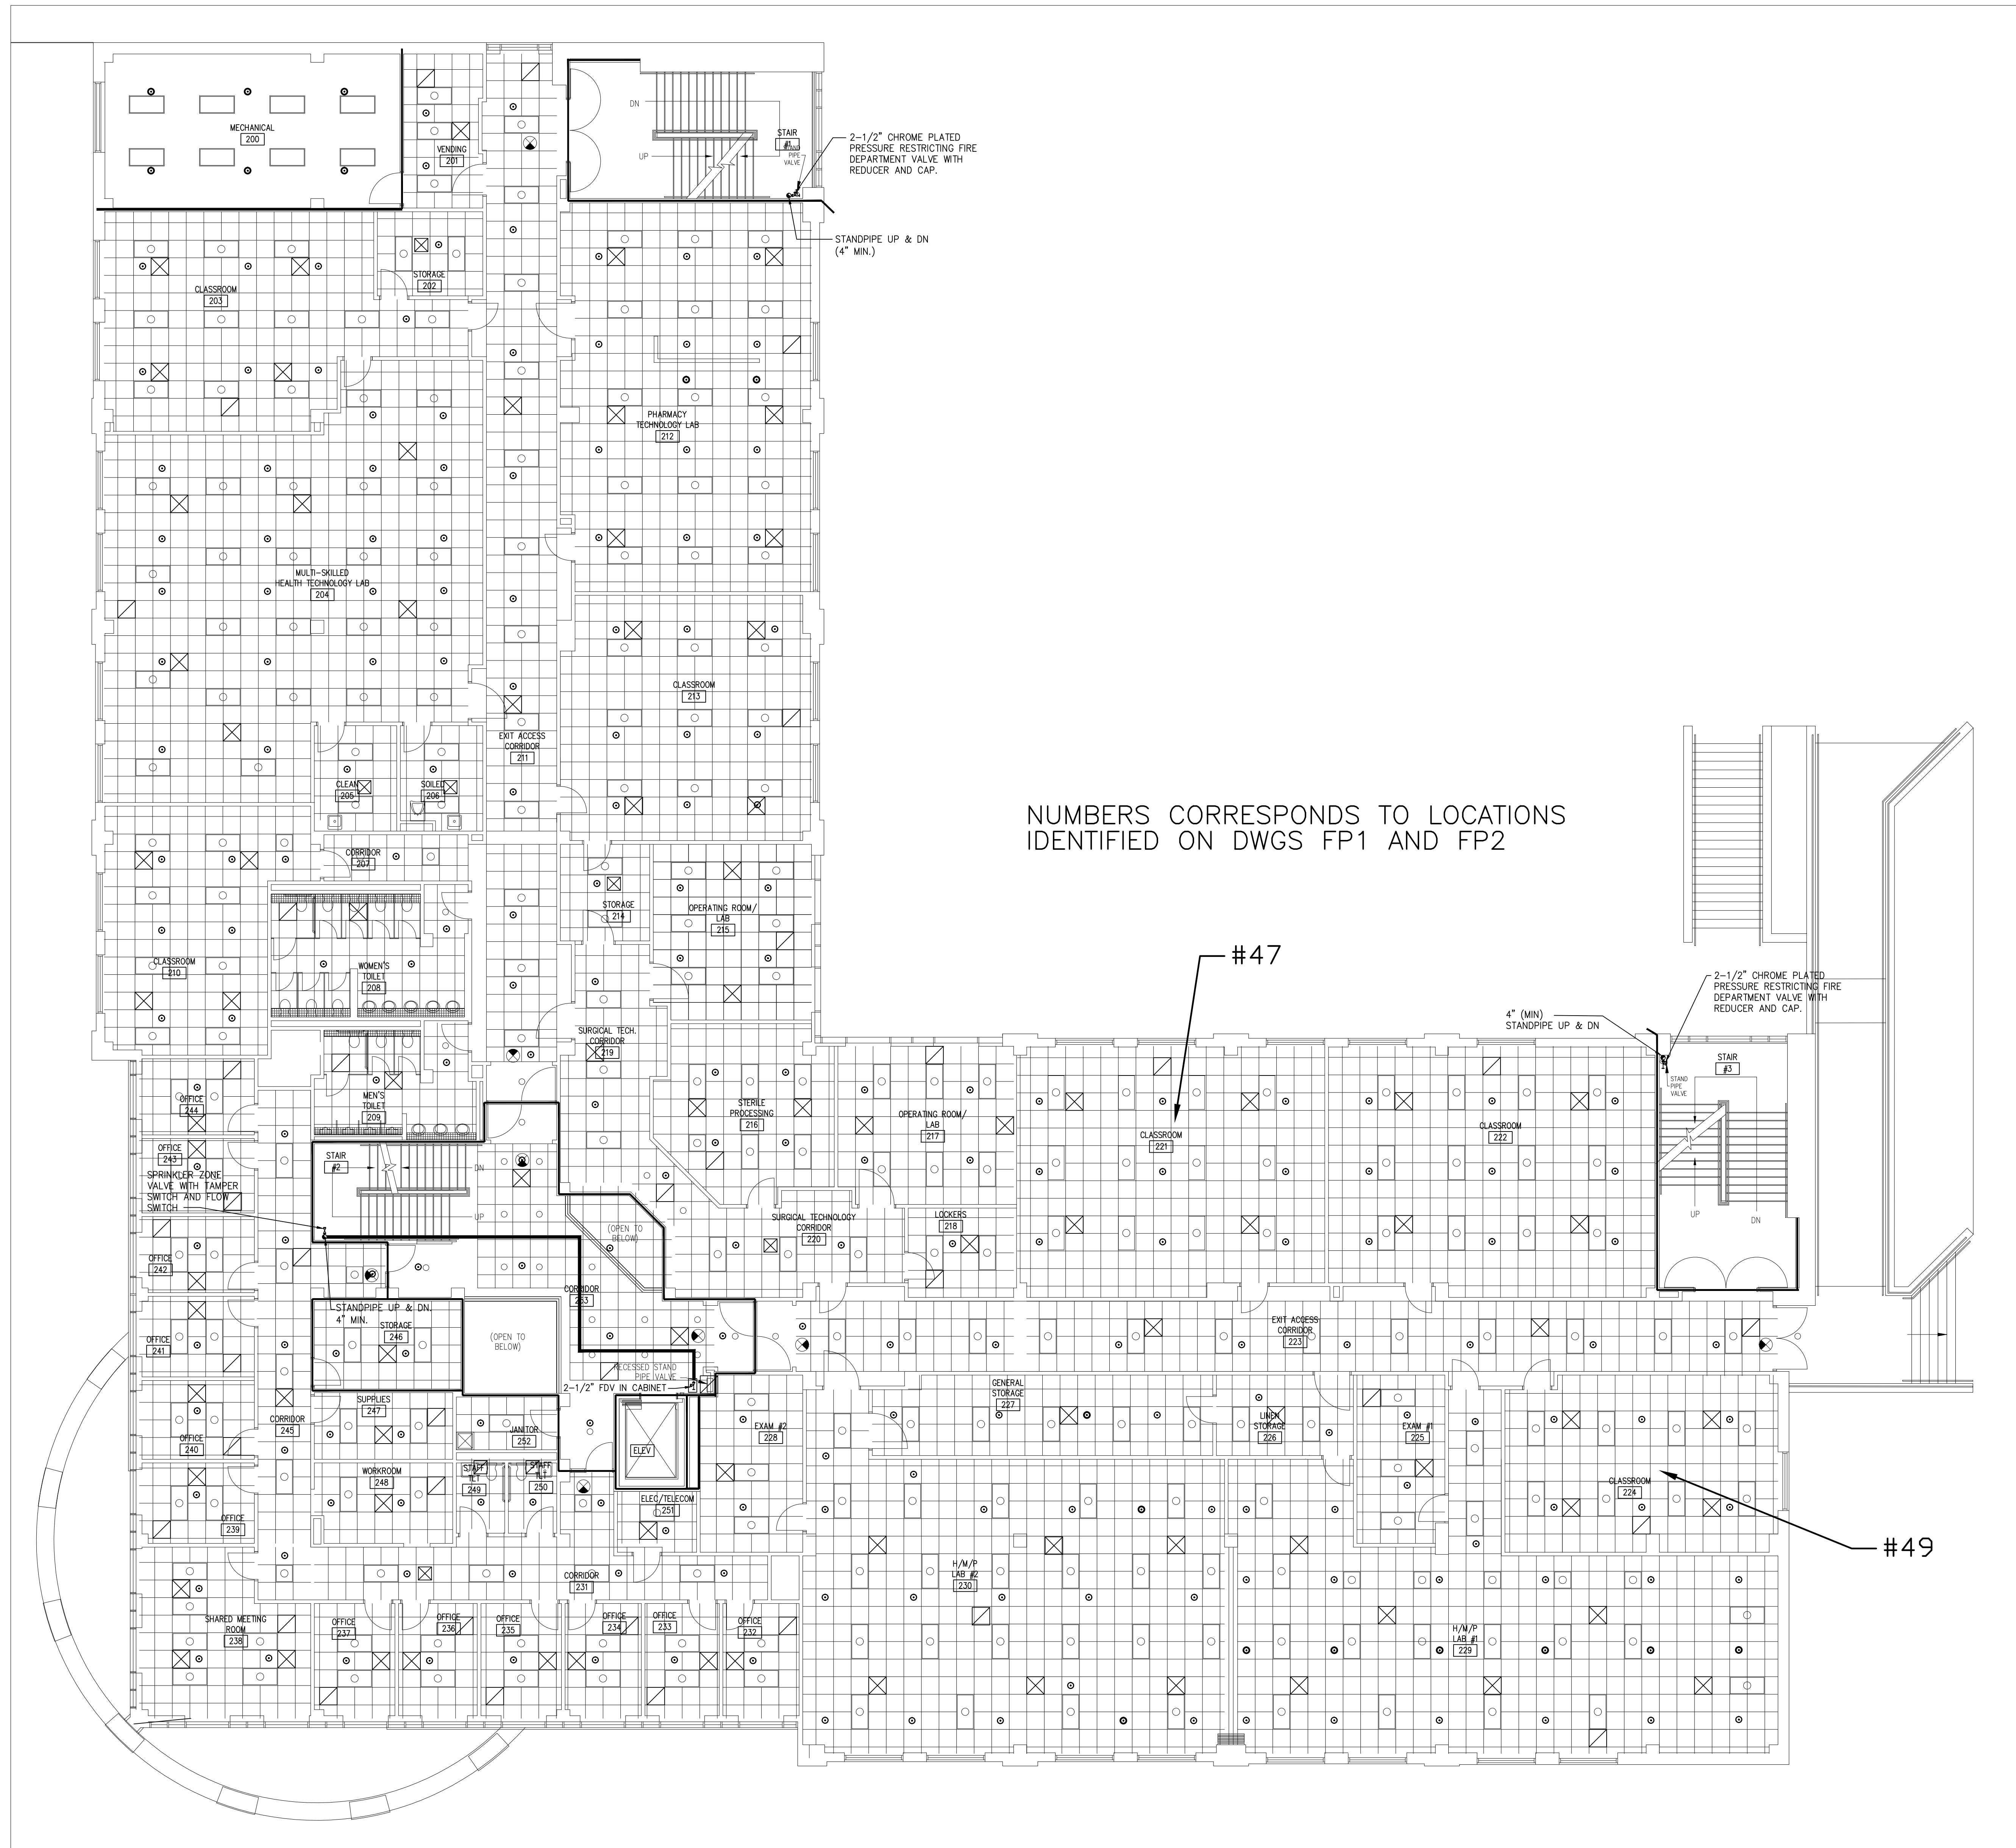
**FP3A**

NUMBERS CORRESPONDS TO LOCATIONS IDENTIFIED ON DWGS FP1 AND FP2

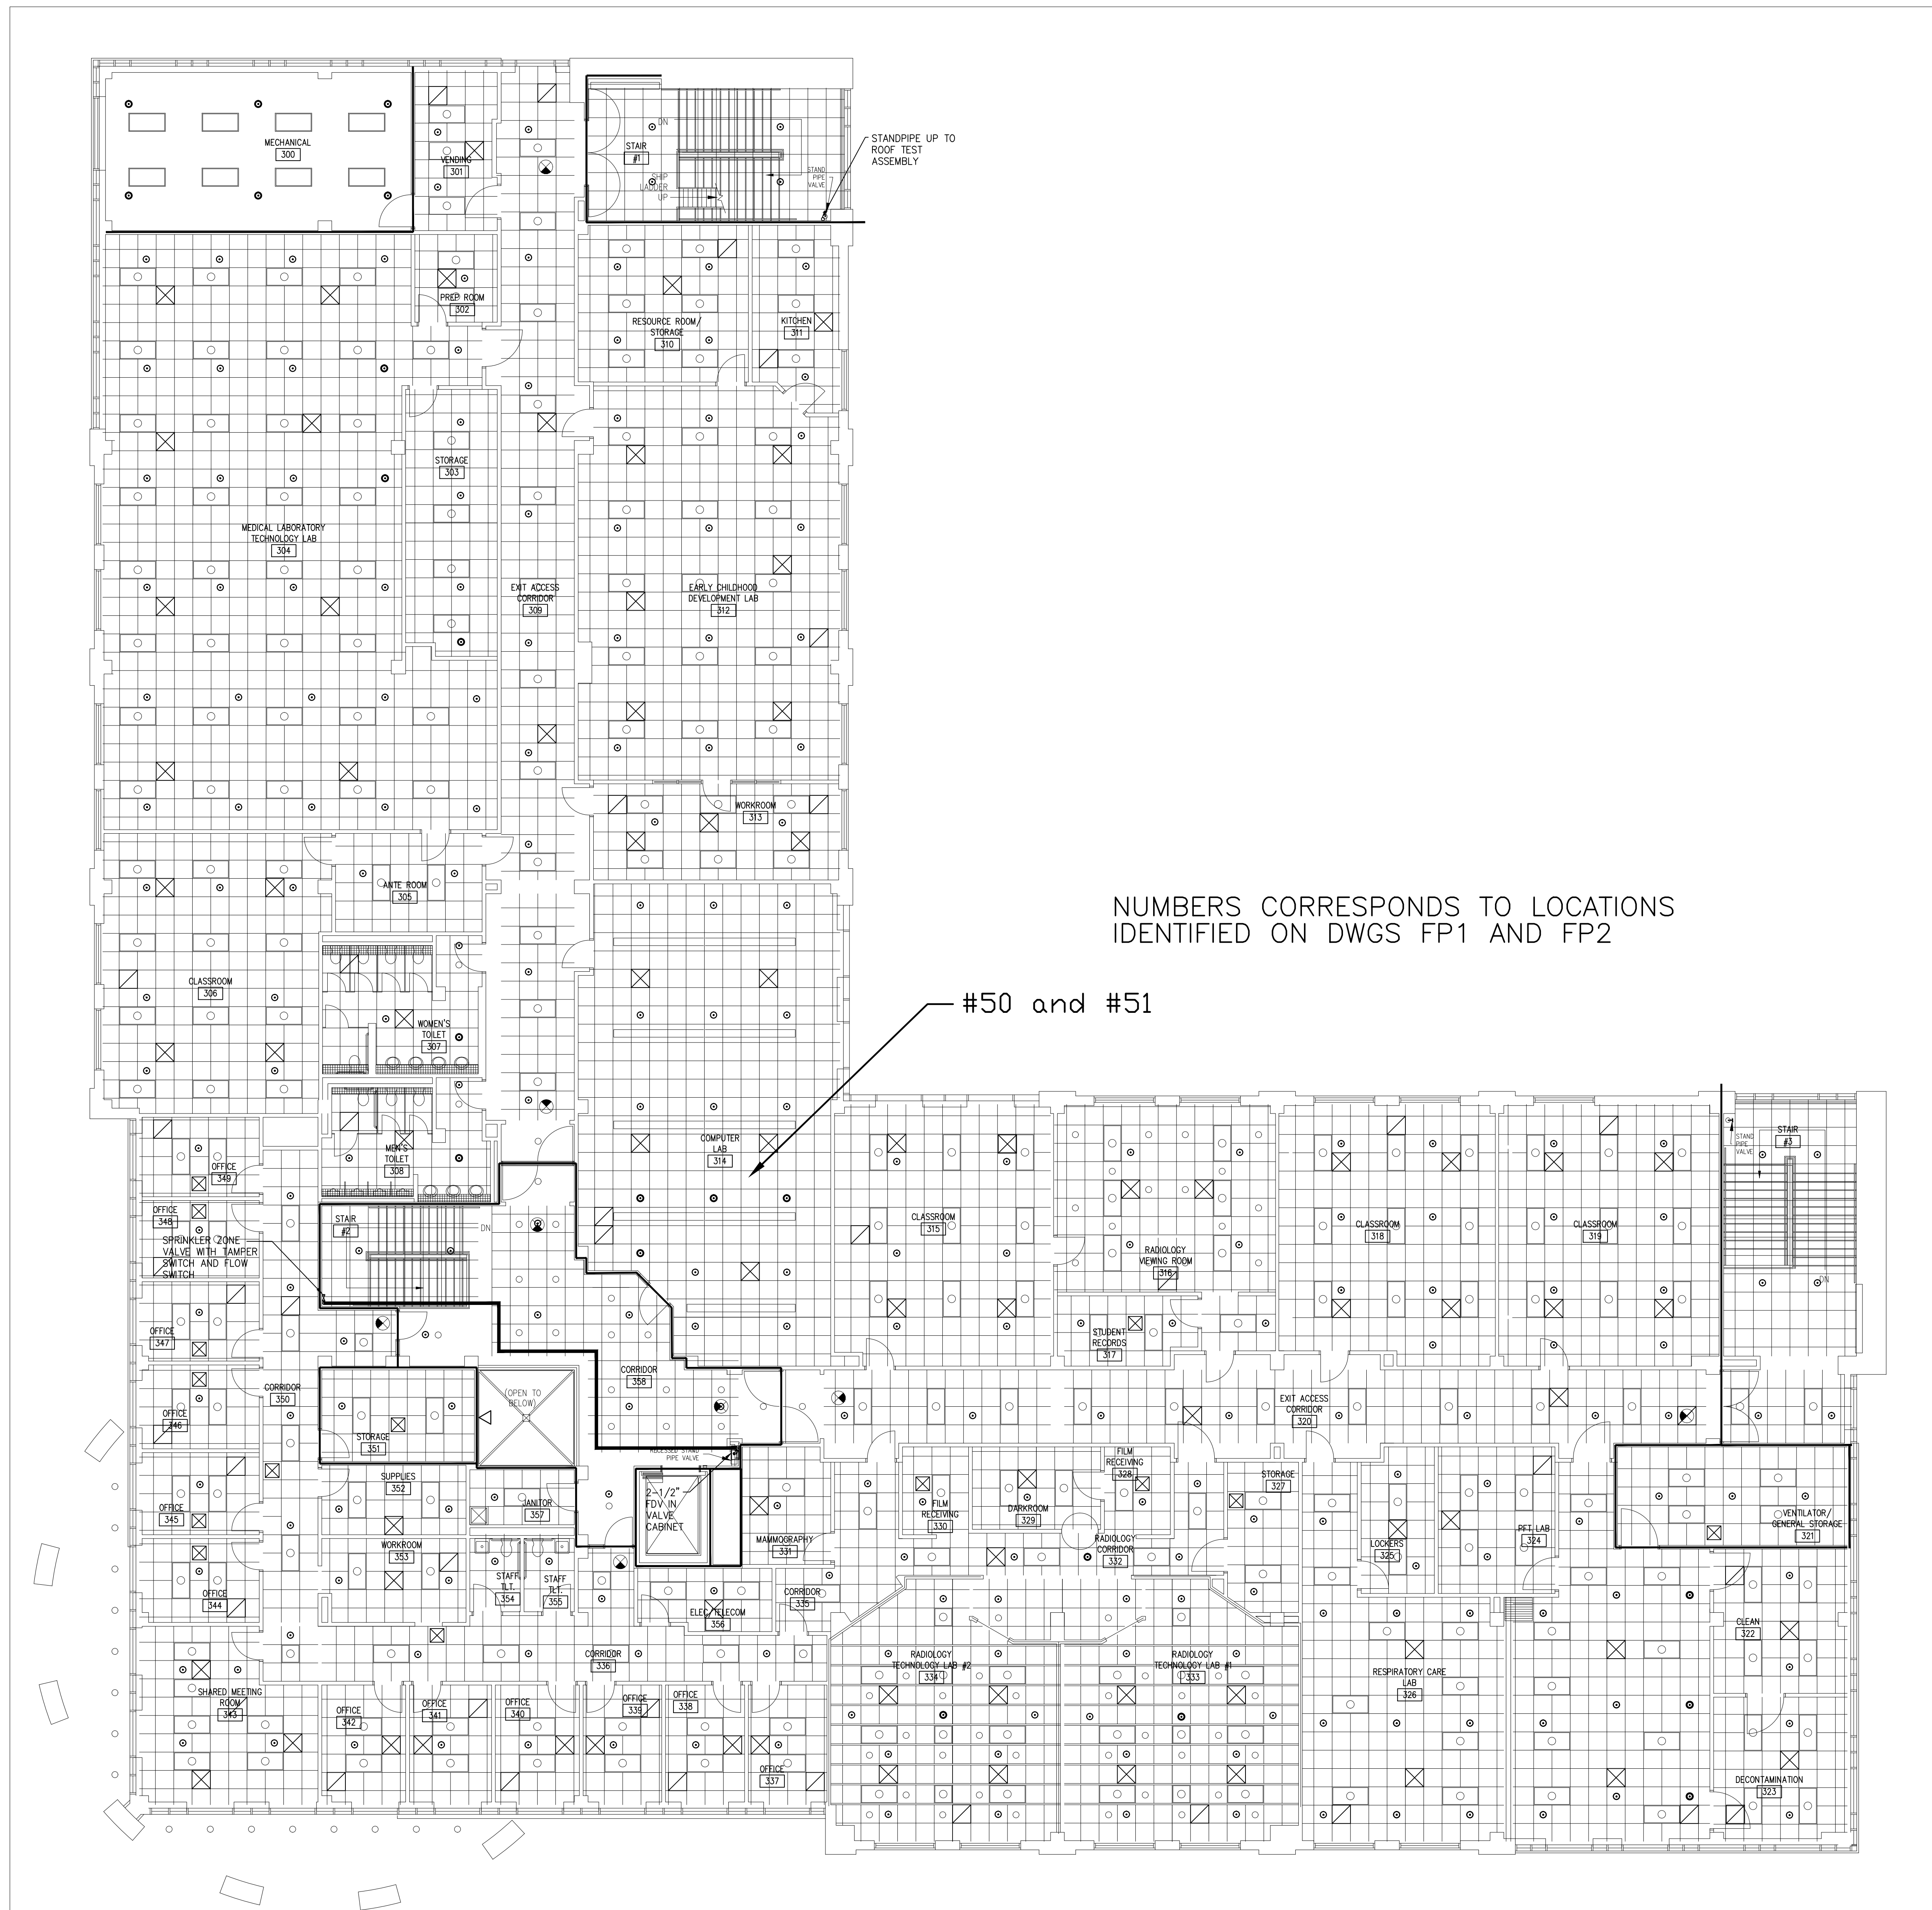
#50 and #51

NUMBERS CORRESPONDS TO LOCATIONS IDENTIFIED ON DWGS FP1 AND FP2
