THE SCOPE OF THIS PROJECT IS TO REPLACE THE CORRODED SPRINKLER PIPING IN THE HEALTH SCIENCE BUILDING. THE PIPING WAS SCANNED UTILIZING ULTRASONIC TESTING DEVICES TO DETERMINE THE AMOUNT OF CORROSION IN VARIOUS SEGMENTS OF THE PIPING SYSTEM. THE SCAN RESULTS ARE INCLUDED ON THESE DRAWINGS FOR THE SECTIONS OF PIPING THAT WAS IDENTIFIED AS NEEDING TO BE REPLACED. SOME OF THE SCANS ARE OF THE SMALL DIAMETER PIPING AT THE ARM-OVERS TO THE SPRINKLER HEADS. THE SCOPE SHALL INCLUDE REPLACING ALL THE ARM-OVERS AND EXISTING SPRINKLER HEADS WITH NEW FLEXIBLE SPRINKLER HEADS.

**1 FIRE PROTECTION PIPE REPLACEMENT INFORMATION**

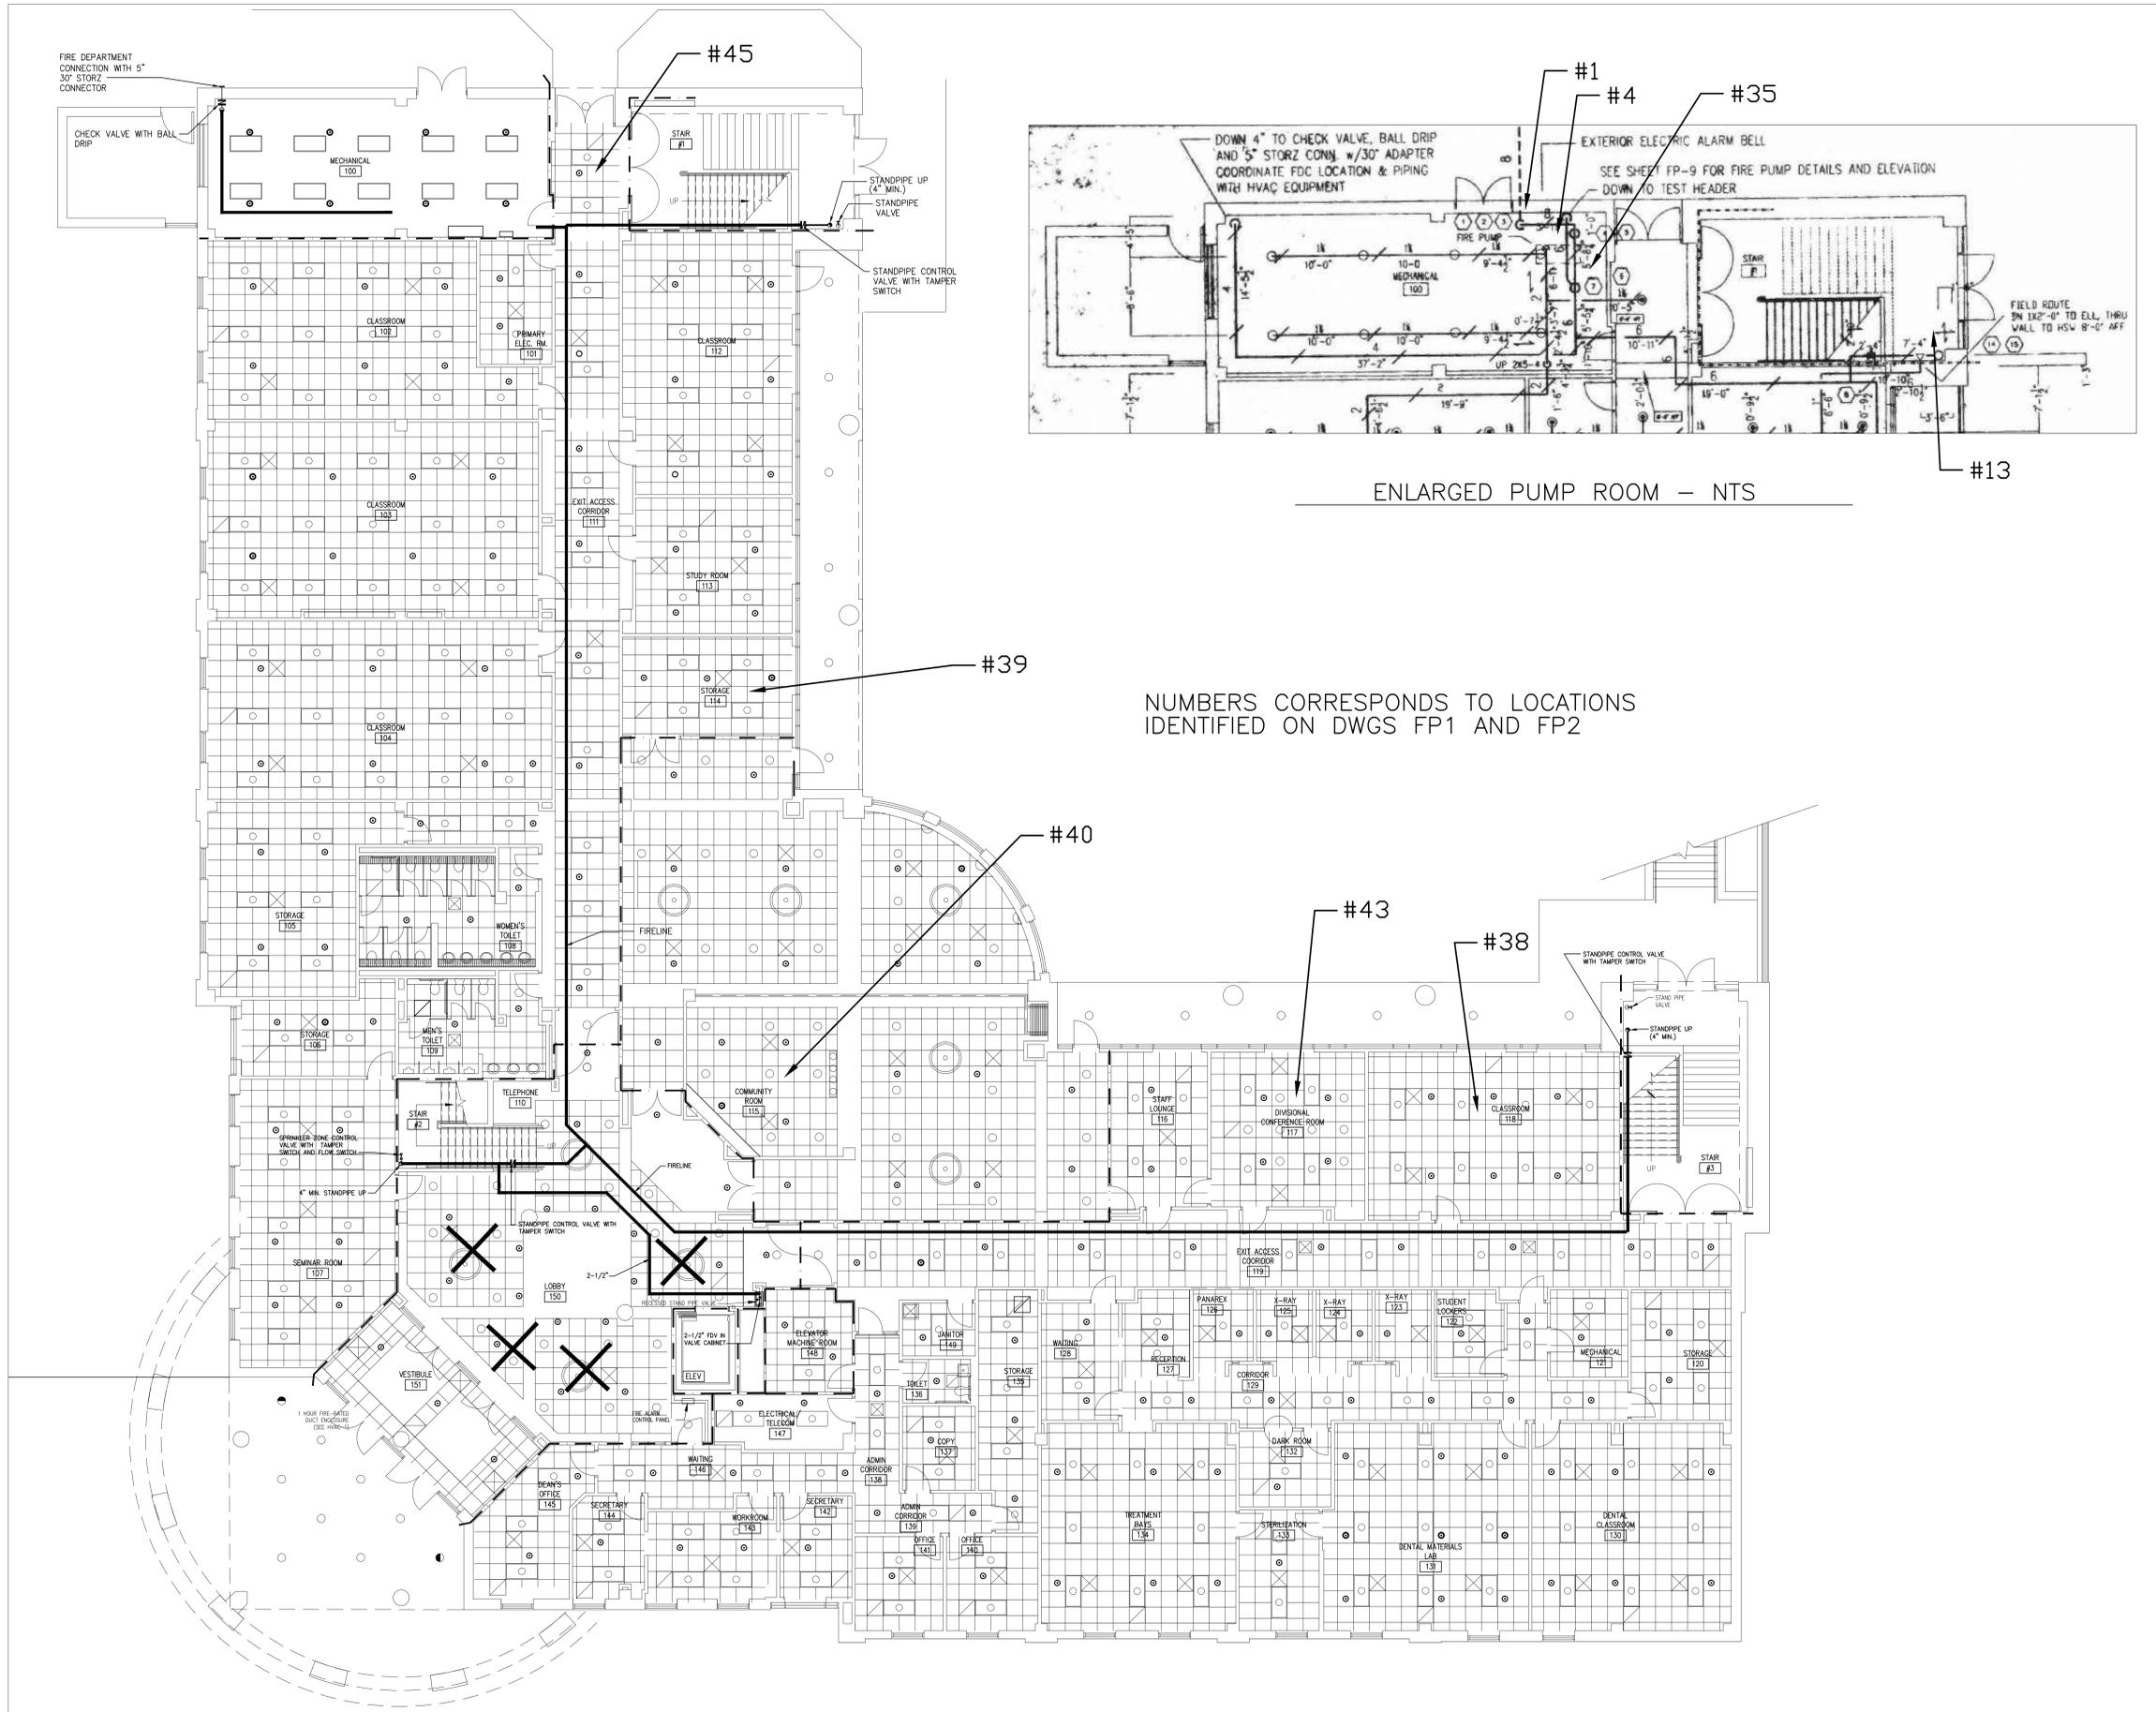
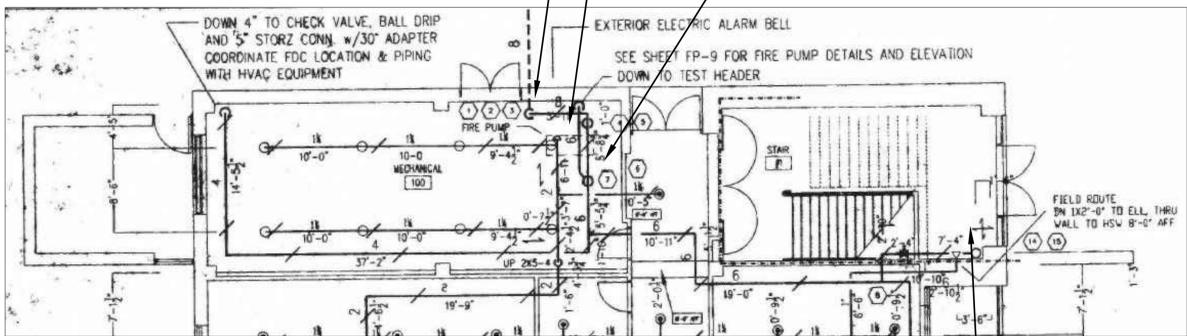
1 FIRE PROTECTION PIPE REPLACEMENT INFORMATION  
NTS  
1/8" = 1'-0"

ENLARGED PUMP ROOM - NTS

NUMBERS CORRESPONDS TO LOCATIONS IDENTIFIED ON DWGS FP1 AND FP2

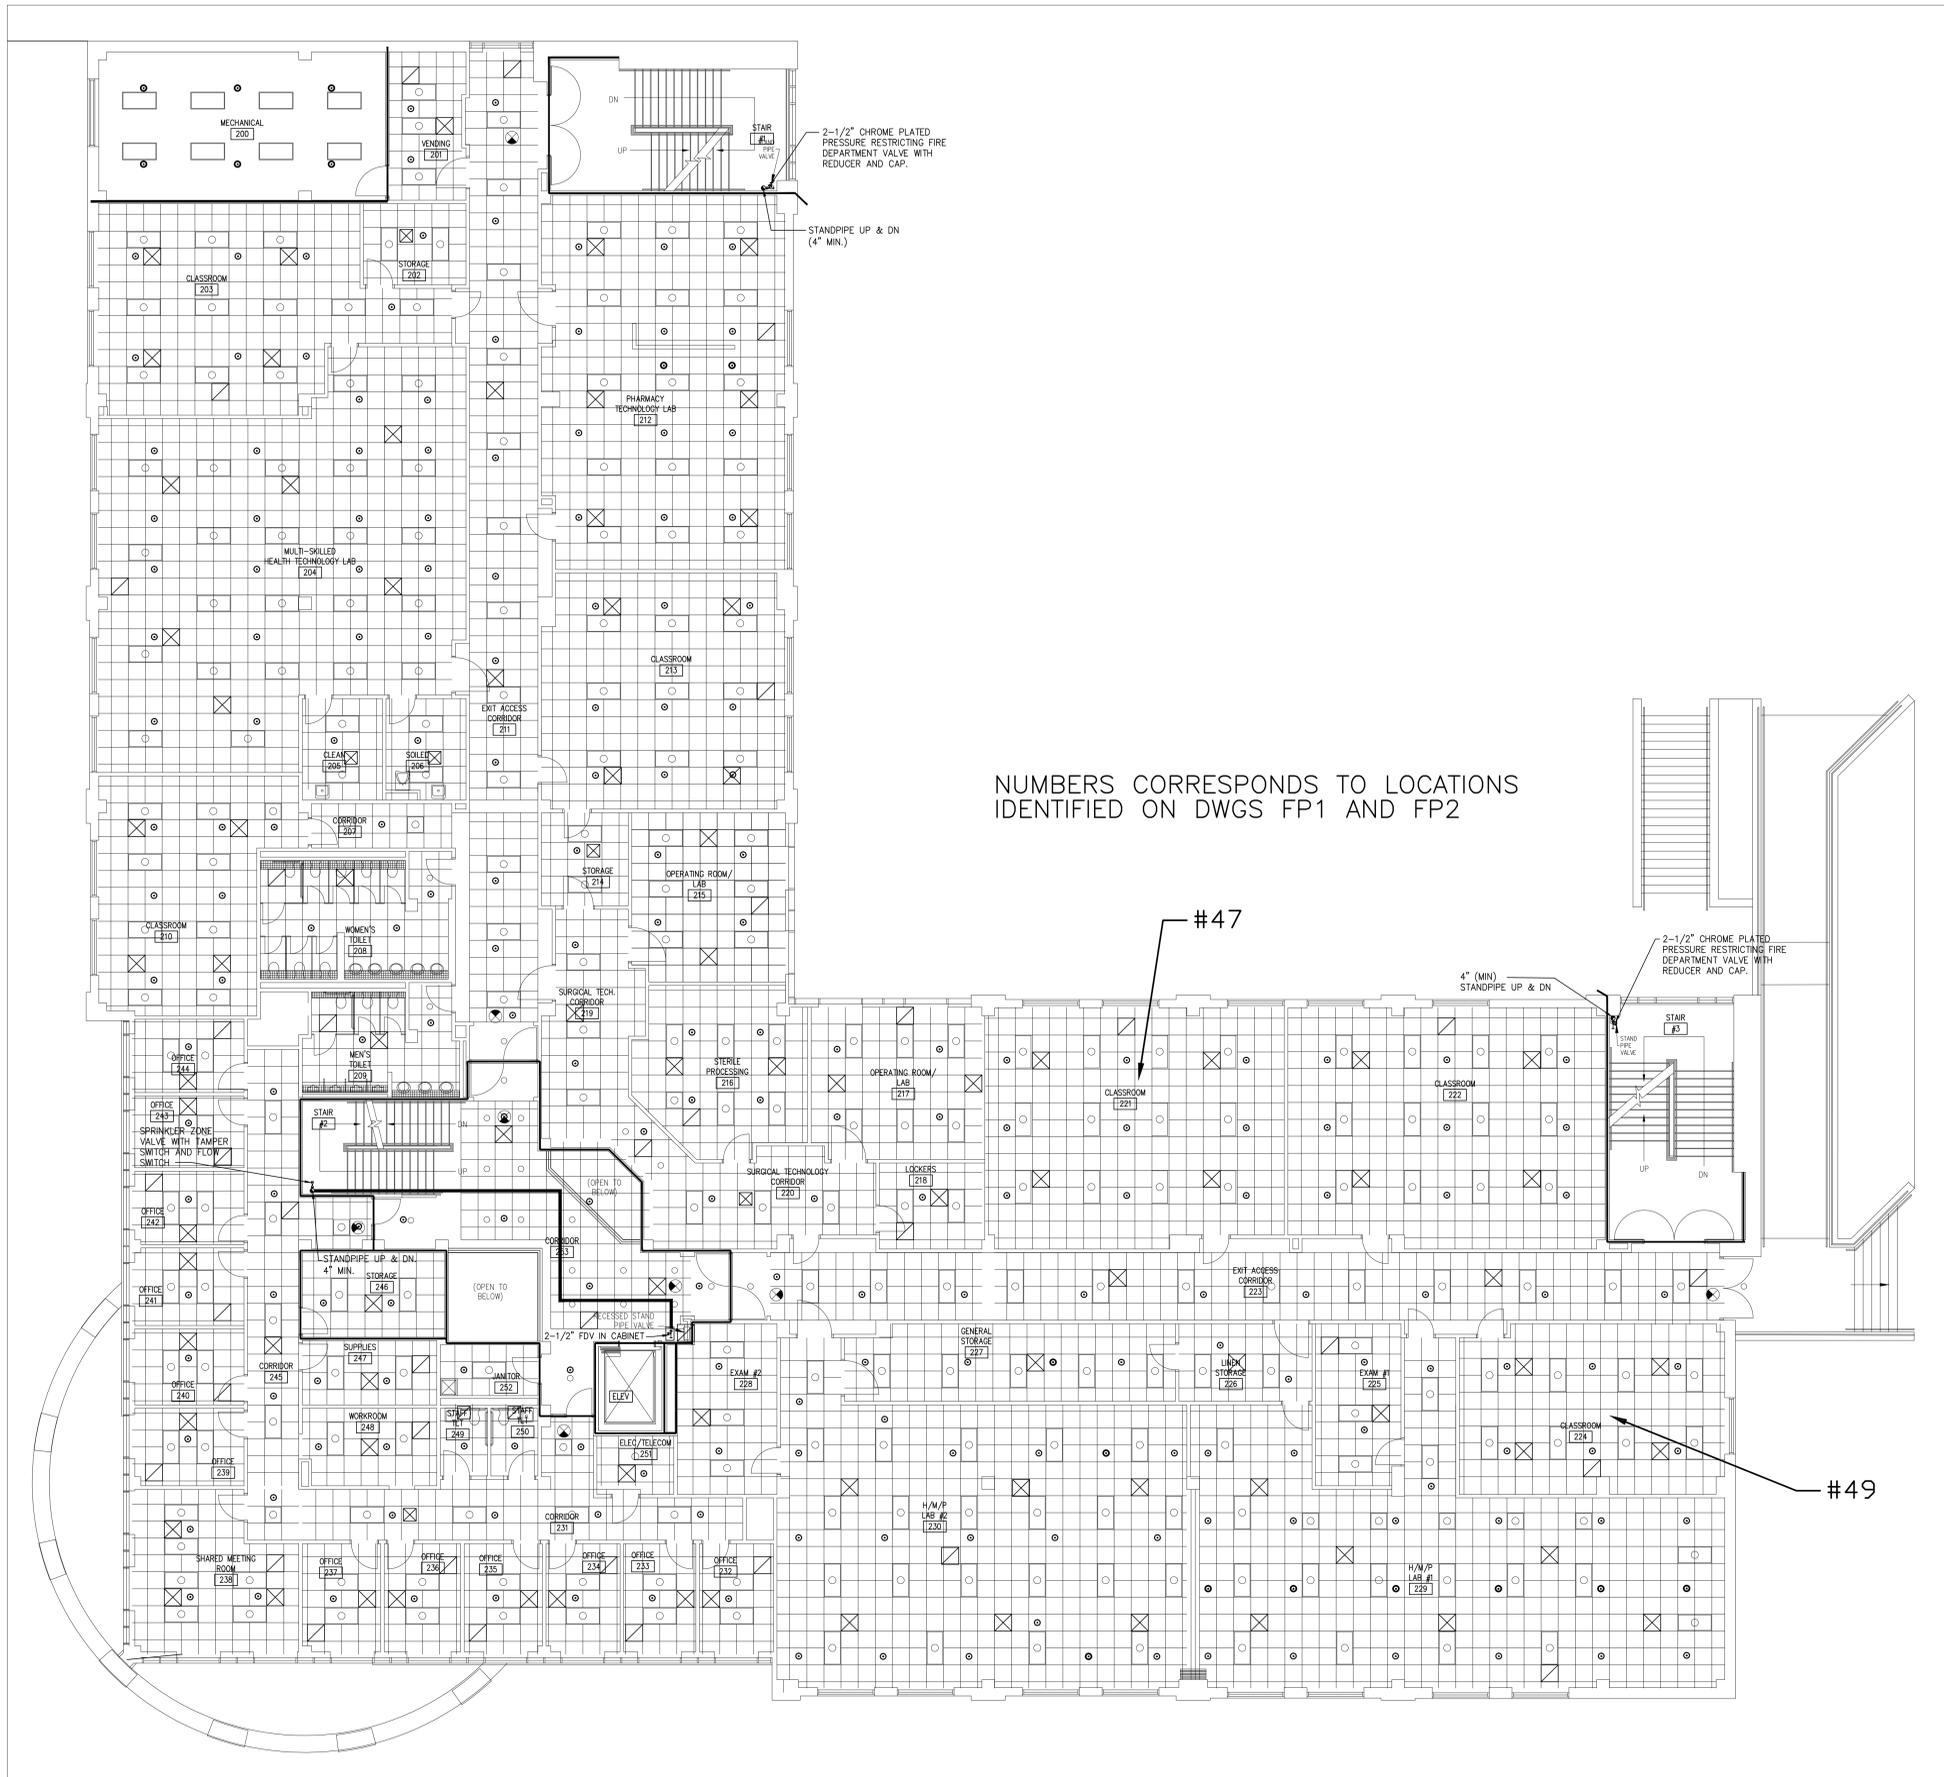
FP3A

NUMBERS CORRESPONDS TO LOCATIONS IDENTIFIED ON DWGS FP1 AND FP2

#47
